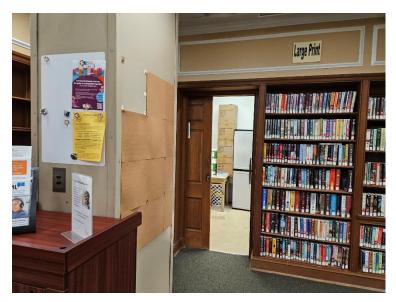
First floor storage space to be converted into an ADA single use restroom. The book cart elevator has been decommissioned for years. It will be removed to open the space. The pocket door will be replaced with an automatic door for ease of use by people with physical disabilities and families with strollers. One section of large print shelving will be removed. This space became functional library space in 1965.

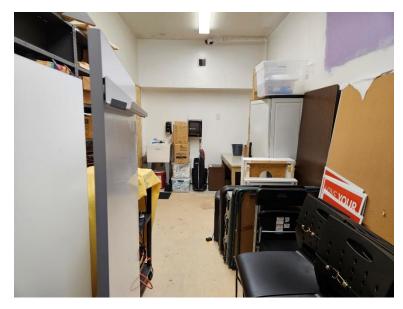
Inside the first floor storage space to be converted to an ADA single use bathroom. 15 ft. x 12 ft. The current utility sink is already connected to plumbing and functional. An air vent to the outside and floor drain will need to be installed. This space became a work room for staff in 1965. It is unknown when it became storage.

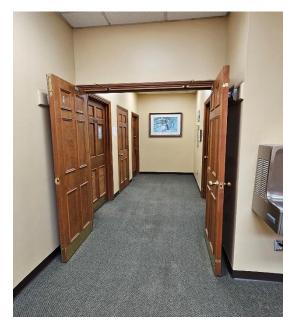
Second floor hallway leading to two public restrooms on the left side of the photo. The fire doors will be moved forward to align with the drinking fountain. This allows for the restroom doors to be relocated and the doorways to be expanded to meet ADA requirements. This area upstairs technically does not qualify for review as it was part of a 1985 addition.

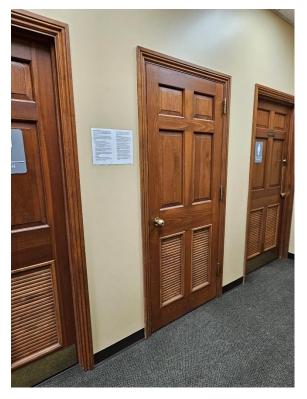
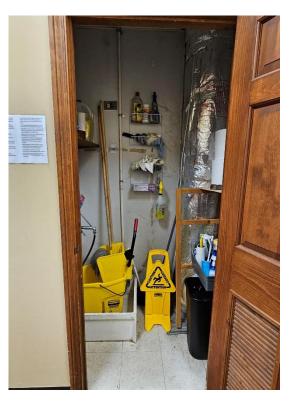
The center utility closet will be eliminated to expand the two second floor restrooms to meet ADA requirements. The HVAC duct will be relocated.

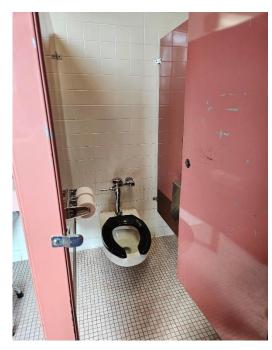
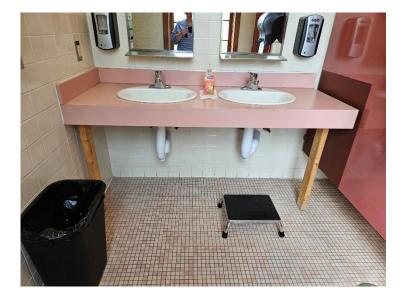
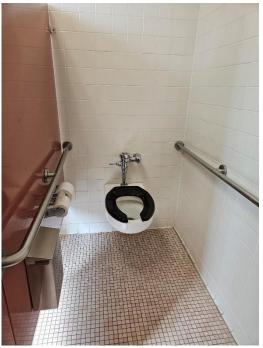
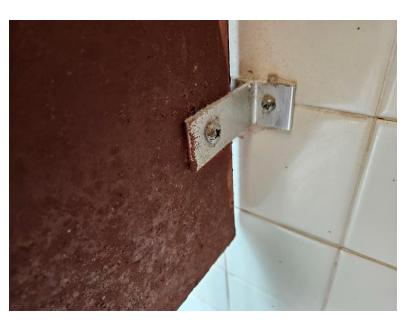
The second floor ladies' room has taken a beating since 1985. The stalls and hardware are rusted. The Township had to build the legs for the sink as the old components broke due to heavy use and children being set on the sink counter. The sink pipes are exposed and many floor tiles are broken. The ventilation is very poor. As noted in the photos, neither stalls are ADA compliant.

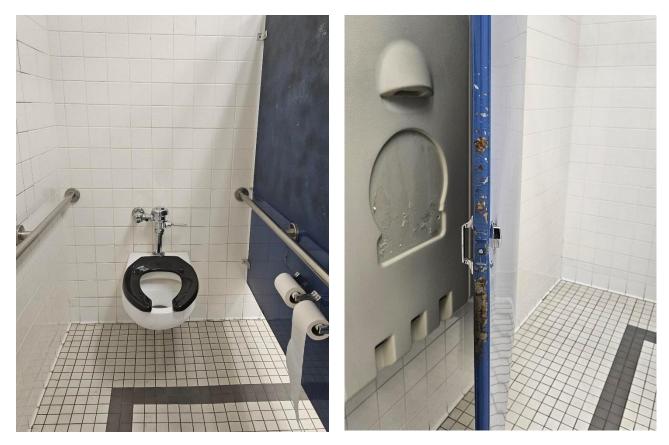
The second floor mens' room has fared slightly better over 38 years. However, the stall is only ambulatory, not ADA compliant. The stall wall, door and fixtures are rusted. There is no new construction for the second floor restrooms.
