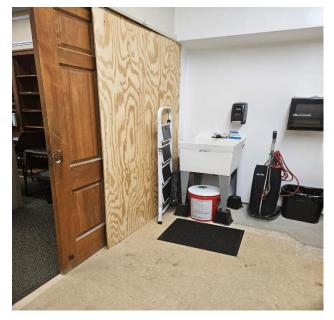
Inside the first floor storage space to be converted to an ADA single use bathroom. 15 ft. x 12 ft. The current utility sink is already connected to plumbing and functional. An air vent to the outside and floor drain will need to be installed. This space became a work room for staff in 1965. It is unknown when it became storage.

There is no new construction and no change to the outside of the facility. Insignificant ground disturbance for a drain install and connection to water/sewer line.
